ANNUAL REPORT FOR 2010

Turkey Branch Site J Mitigation Site
Madison County
TIP No. R-2518A

Prepared By:
Natural Environment Unit & Roadside Environmental Unit
North Carolina Department of Transportation
December 2010

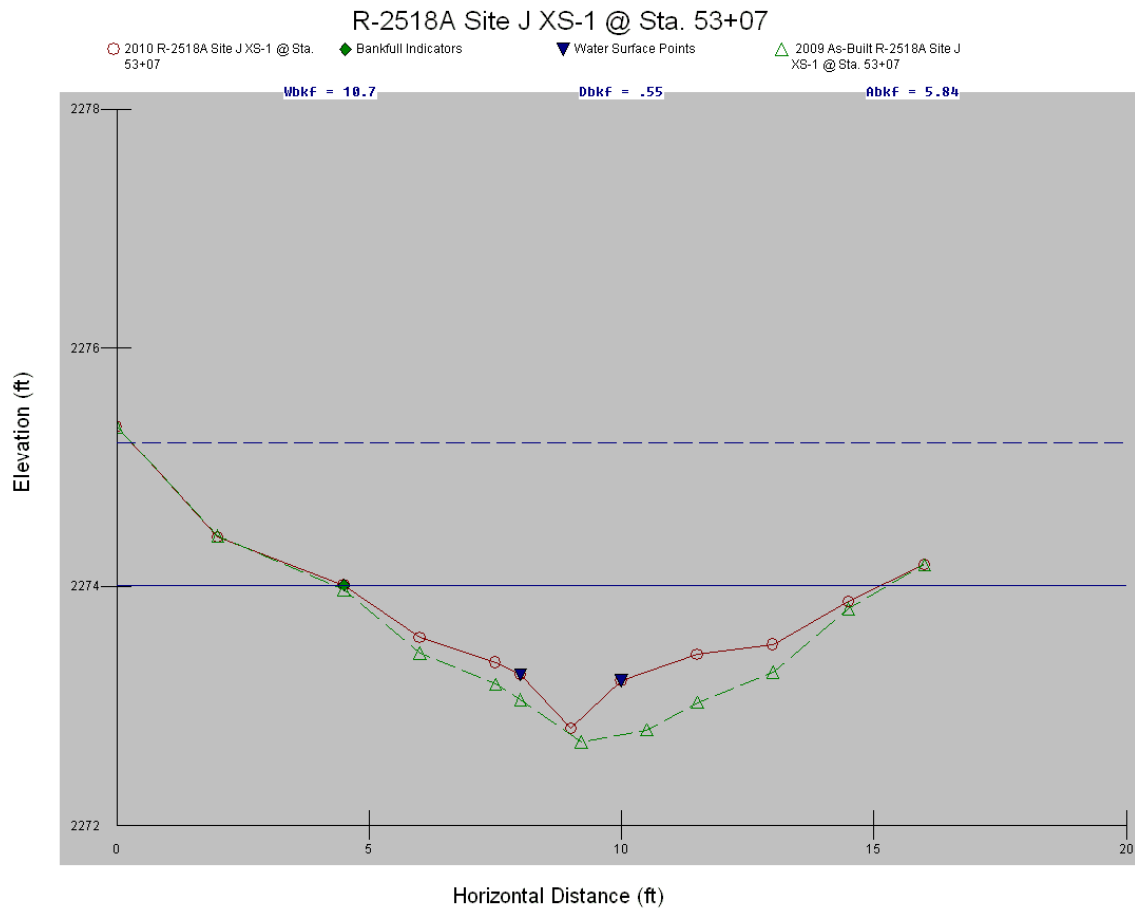
Based on comparisons of the As-Built to Year 1 monitoring data, all of the cross sections appear stable with little or no active bank erosion. Graphs of the cross sections are presented in Appendix A. Future survey data will vary depending on actual location of rod placement and alignment; however, this information should remain similar in appearance. The longitudinal profile showed that the channel was stable for the 2010 monitoring evaluation. Pebble counts were not required per the permit conditions and therefore were not completed.

Site J: Cross-Section #1 (Riffle) Abbreviated Morphological Summary					
	2010	2011	2012	2013	2014
Bankfull Cross Sectional Area (ft ²)	5.84				
Maximum Bankfull Depth (ft)	1.2				
Width of the Floodprone Area (ft)	15.72				
Bankfull Mean Depth (ft)	0.55				
Width/Depth Ratio	19.42				
Entrenchment Ratio	1.47				
Bankfull Width (ft)	10.68

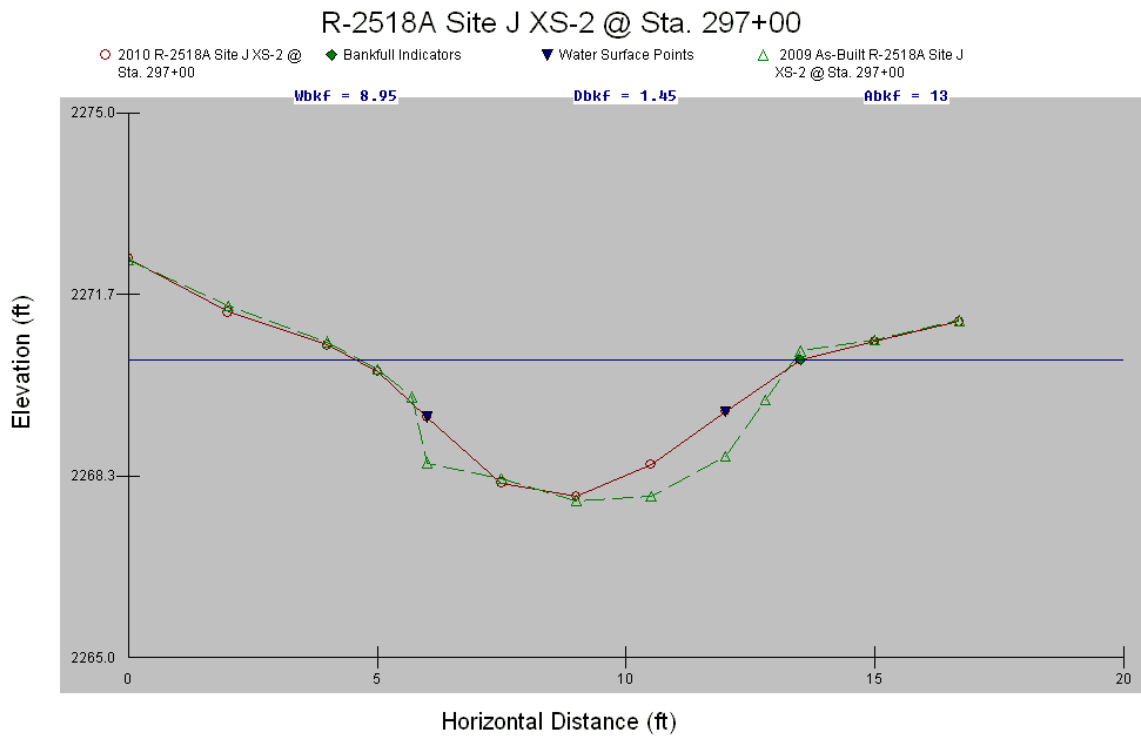
Site J: Cross-Section #2 (Pool) Abbreviated Morphological Summary					
	2010	2011	2012	2013	2014
Bankfull Cross Sectional Area (ft ²)	12.96				
Maximum Bankfull Depth (ft)	2.51				
Bankfull Mean Depth (ft)	1.45				
Bankfull Width (ft)	8.95

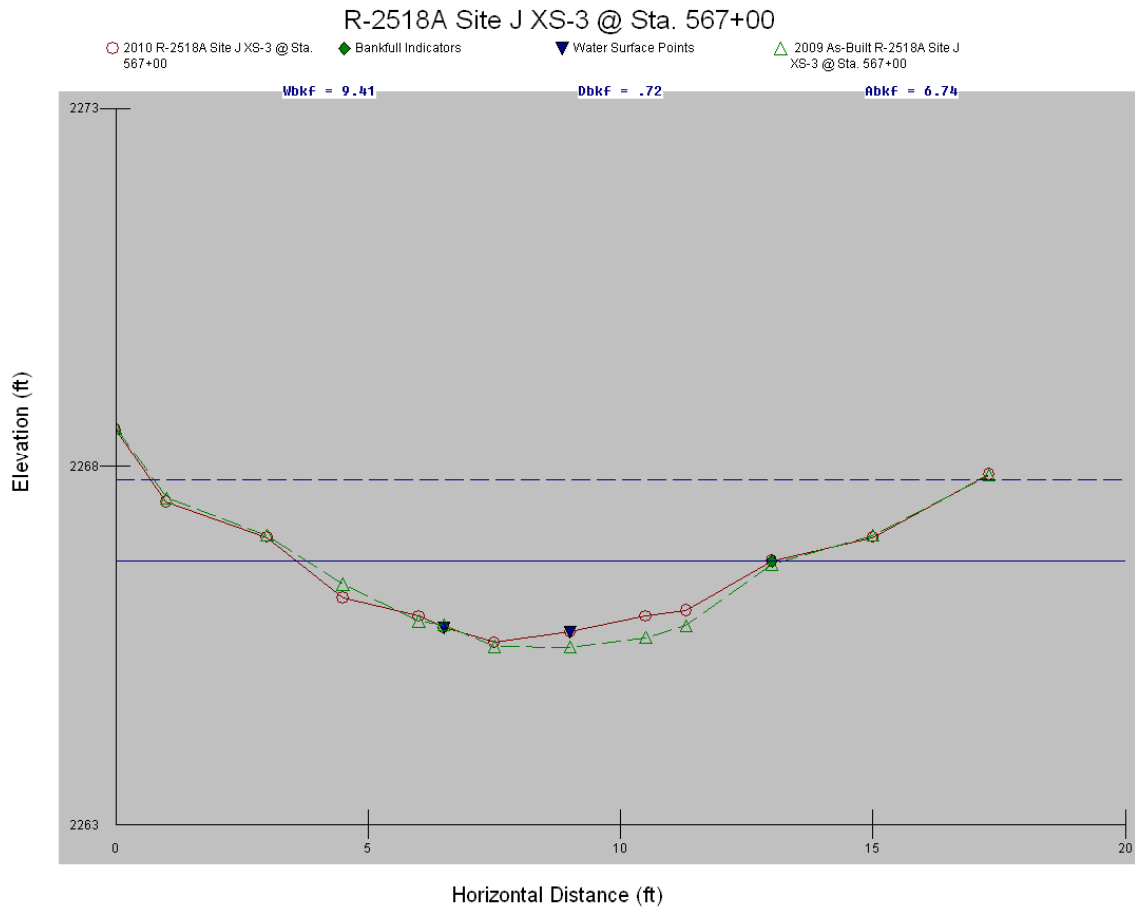
Site J: Cross-Section #3 (Riffle) Abbreviated Morphological Summary					
	2010	2011	2012	2013	2014
Bankfull Cross Sectional Area (ft ²)	6.74				
Maximum Bankfull Depth (ft)	1.14				
Width of the Floodprone Area (ft)	16.42				
Bankfull Mean Depth (ft)	0.72				
Width/Depth Ratio	13.07				
Entrenchment Ratio	1.75				
Bankfull Width (ft)	9.41

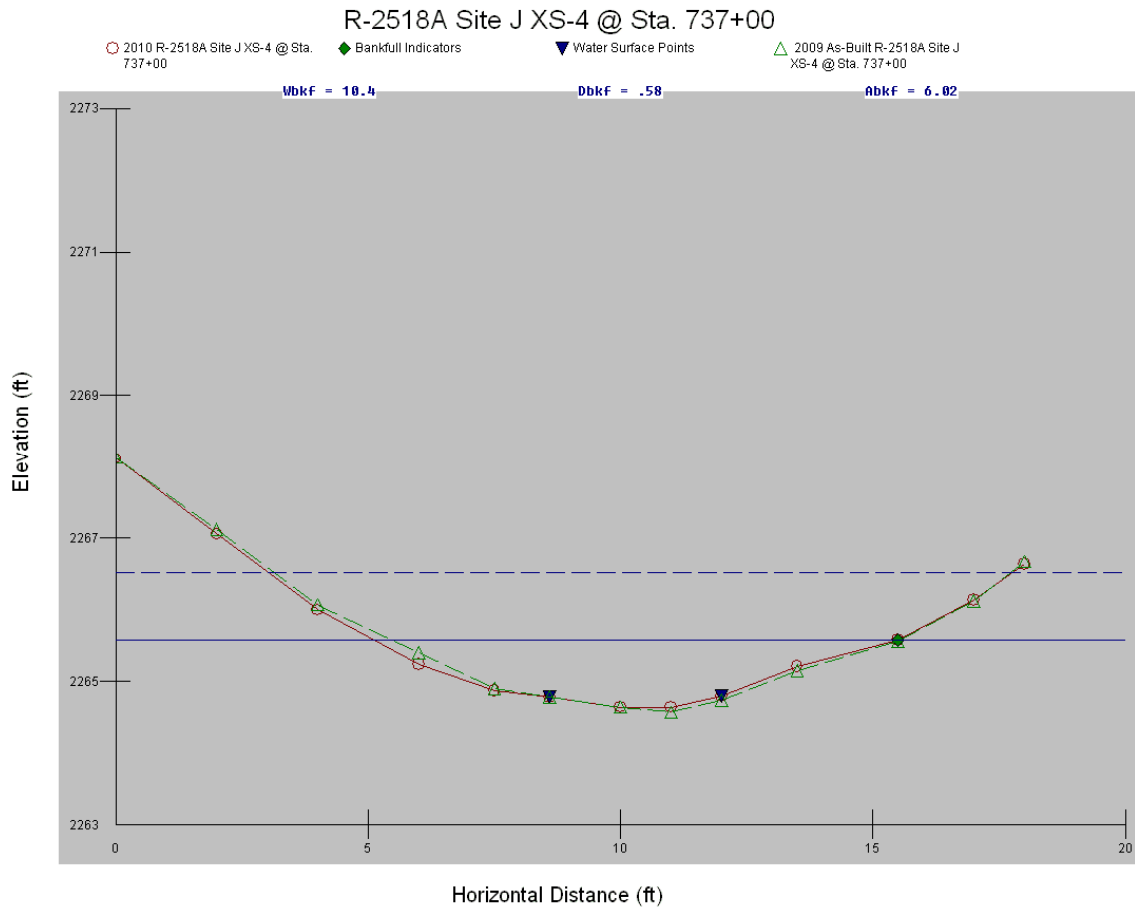
Site J: Cross-Section #4 (Riffle) Abbreviated Morphological Summary					
	2010	2011	2012	2013	2014
Bankfull Cross Sectional Area (ft ²)	6.02				
Maximum Bankfull Depth (ft)	0.94				
Width of the Floodprone Area (ft)	14.74				
Bankfull Mean Depth (ft)	0.58				
Width/Depth Ratio	17.91				
Entrenchment Ratio	1.42				
Bankfull Width (ft)	10.39

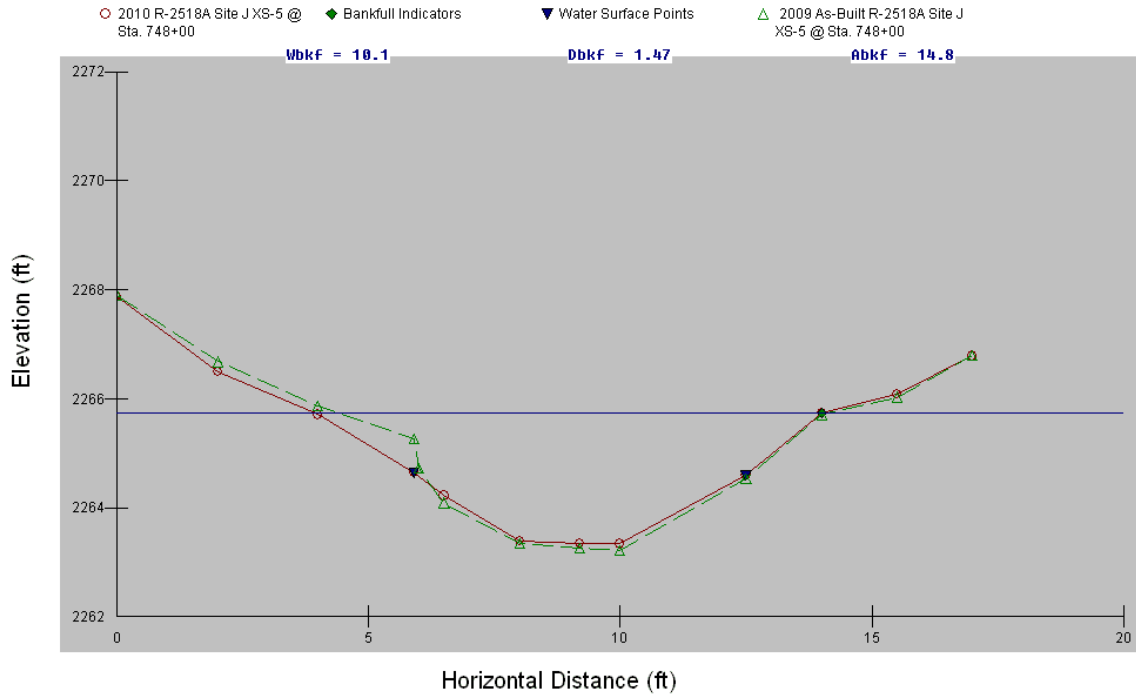
R-2518A Site J XS-5 @ Sta. 748+00

Site J: Cross-Section #5 (Pool) Abbreviated Morphological Summary					
	2010	2011	2012	2013	2014
Bankfull Cross Sectional Area (ft ²)	14.82				
Maximum Bankfull Depth (ft)	2.4				
Bankfull Mean Depth (ft)	1.47				
Bankfull Width (ft)	10.08
